## **Copper Mountain Mine Tailings Dam Safety Review Supplement**

**Daniel Brox**

**Abstract:**—**Copper** Mountain Mine tailings dam slope stability research based on recommendations of the 2021 Tetra Tech Dam Safety Review, including computation of tailings dam factors of safety, satellite imagery, steady state and transient seepage analyses, assessment of internal erosion risk, and flow liquefaction hazard analysis. Dam topographic information provided by foundation investigation and annual dam safety inspection reports is used to specify 3D dam models and compute dam factors of safety that satisfy normal operating requirement but are in possible violation of post-seismic requirement.

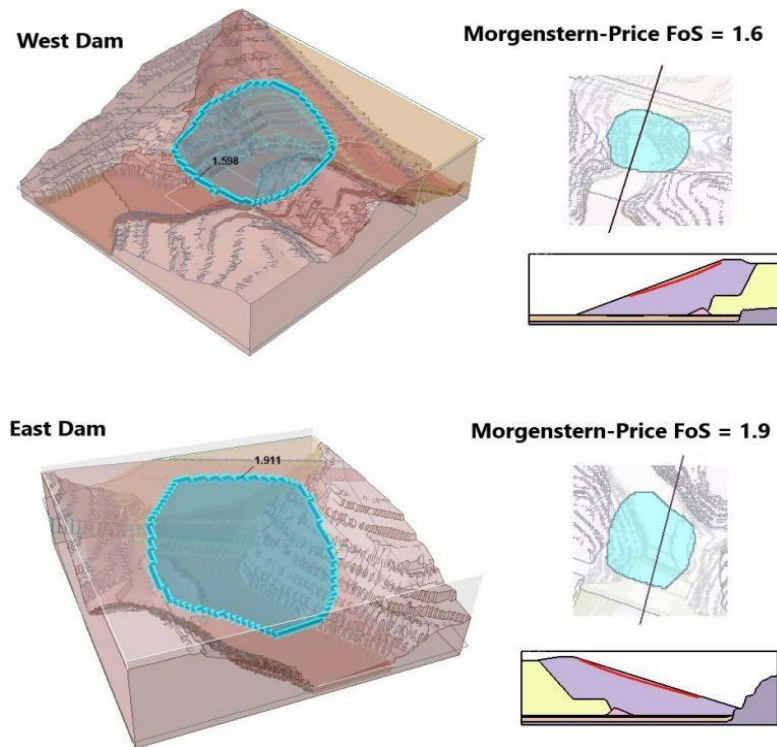
**Figure 2** shows the result of computing 3D FoS values for models of the West Dam and East Dam using Rocscience Slide3. The 3D models are based on valley topographic data provided by the foundation investigation documentation and 2016/2023 ADSI reports, and dam construction projections based on the 2023 ADSI report. Because the foundation investigation documentation showed boreholes in the vicinity of the West and East starter dams having average surface/bedrock elevations of 810.4m/795.4m and 811.8m/781.6m elevations, while the 2023 ADSI indicates the West and East starter dam base elevations for sections B1 and A2 are 800m, foundation topography was simplified to have uniform surface/bedrock elevations of 800m/780m, since the sand and gravel material in the foundation below the elevation of the surface lacustrine clay layers is not anticipated to affect slip surface geometry. Model phreatic surfaces are based on calibration of FEFLOW 2D seepage analyses to 2023 piezometer data, assuming water is ponded against dam crests during probable maximum flood events. For minimal slip surfaces determined by the Slide3 classic ellipsoidal particle swarm search, the Morgenstern-Price FoS value is 1.6 for the West Dam is 1.6, and 1.9 for the East Dam. The fact that neither 3D slip surface passes through the tailings and clay foundation demonstrates the importance of the narrowness of dam valley geometry to enhancing stability of the dam slopes.

**Figure 2.** West Dam and East Dam 2025 3D Morgenstern-Price FoS values computed for minimal spline slip surfaces determined by Rocscience Slide3 classic ellipsoidal particle swarm search. Phreatic surface based on 2D FEFLOW analysis of probable maximum flood conditions.

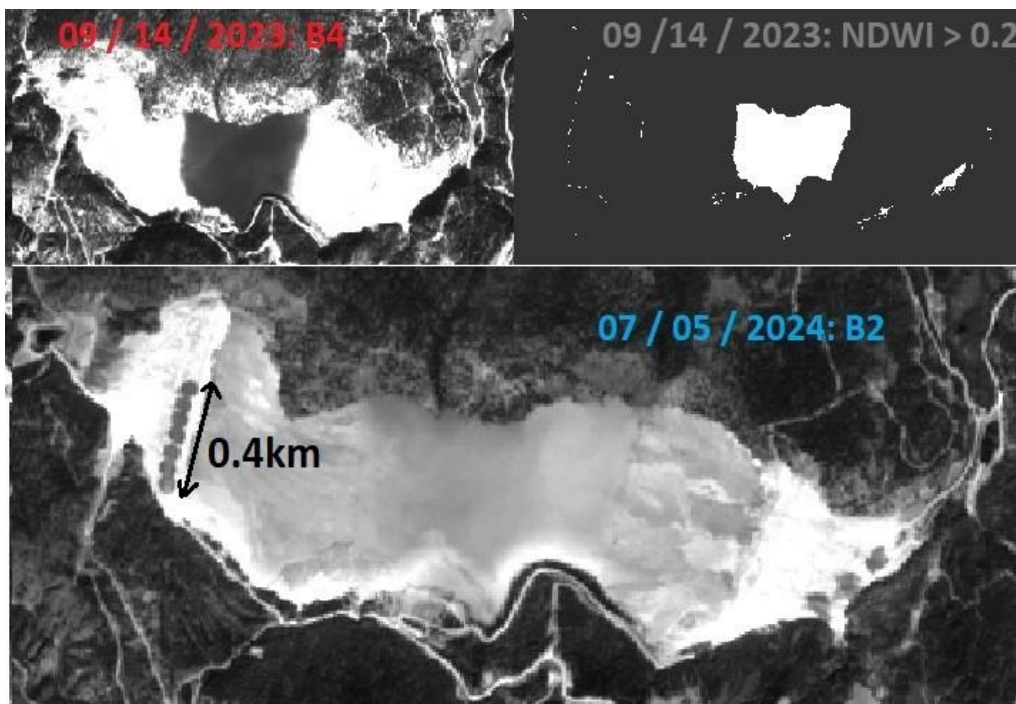
to detect presence of surface water [Du, 2016, O'Donovan, 2022]. **Figure 3-top** shows images of the Copper Mountain Mine TSF on September 14, 2023, filtered in the red band B4 (left) and binary processed to display  $NDWI > 0.2$  to identify presence of surface water. **Figure 3-bottom** shows an image of the TSF on July 5, 2024, filtered through band B2 (blue-490nm), in which circular surface structures of approximate diameter 60 and 100km with optical reflectivity less than surrounding dam material are visible on the West and East dam downstream slopes. A hypothesis offered for presence of the structures in accordance with the 2021 DSR is that they were formed by sprinkler systems to limit dust generation.

**Figure 3.** Sentinel-2 images Copper Mountain Mine TSF, dated 09/14/2023 (top), and 07/05/2024 (bottom). Top images show the TSF in red band B4 (left), in which boundaries of the tailings pond are clear, and the same image binary processed for the condition  $NDWI > 0.2$  to identify presence of water at the surface of the TSF. The bottom image shows the TSF in blue band (B2) in which 7 circular structures on the West Dam crest/downstream slope of approximate diameter 60km and 3 circular structures on the East Dam downstream slope of approximate diameter 100m are visible, and

distinguishable from dam downstream slope, beach, and tailings pond materials by their reflectance in blue, red, and infrared bands.

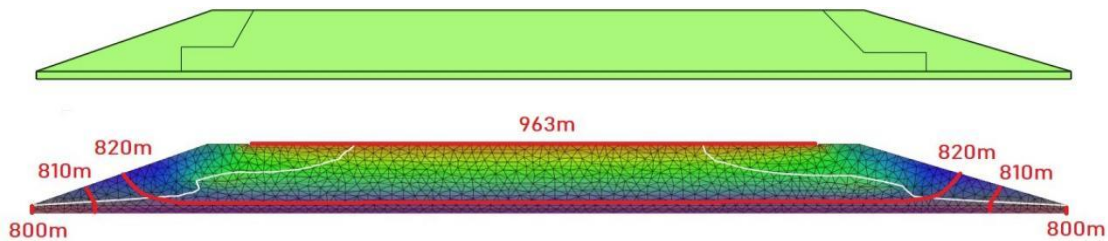
**Figure 4** shows the FEFLOW computed 2023 phreatic surface level and hydraulic head isolines for the entire TSF and its foundation analyzed as a simplified 2 dam system in which drainage systems are ignored, beach lengths are 0m, and the material permeabilities listed in **Table 5** have been used. This analysis indicates the 2023 hydraulic head in TSF foundation upstream of West and East starter dams is approximately constant at 810m. The total seepage flows out of the West and East Dams are computed to be 1.4L/s/m and 1.2L/s/m, and in both cases more than 90 percent of this flow passes through the foundation. These seepage analysis results are in contrast to 2014 piezometer readings of VWP10-05W-3/VWP10-01E-3 in West/East Dam upstream foundations in

excess of 835m/845m, pointing to the importance of considering the effect of 3D TSF geometry on seepage flow, and accounting for any low permeability path from the TSF pond through the TSF abutments into the foundation as previously reported to be of concern [Klohn Crippen, 1998].

**Figure 4.** West/East Dam FEFLOW analysis of 2023 2 dam system indicates hydraulic head in TSF foundation upstream of West and East starter dams is approximately constant at 810m, in contrast to 2014 piezometer readings of VWP10-05W-3/VWP10-01E-3 in West/East Dam upstream foundations in excess of 835m/845m.

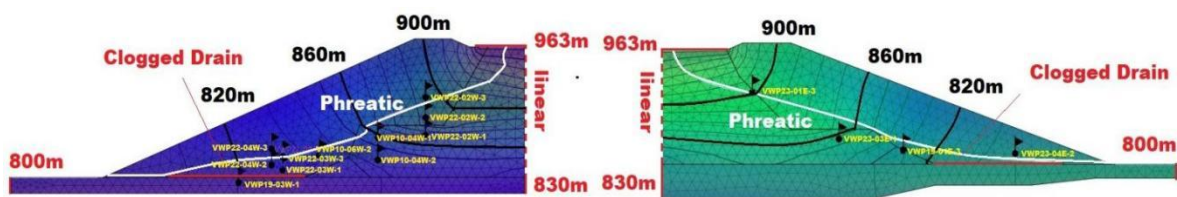
**Figure 5** shows West/East Dam FEFLOW steady state seepage analyses with drain function and boundary conditions adjusted to obtain approximate agreement of hydraulic heads with 2023 readings of West/East Dam piezometer readings. For both dams, an upstream foundation total head of 830m was assigned based on readings of piezometer VWP12-01E-2 and results of analyzing the 2 dam system. For the West Dam, to obtain agreement with downstream piezometer VWP22-04W-1 and VWP22-03W-3 readings of 811m and 827.5m, it was necessary to assume 100m of the blanket/finger drain system downstream of the starter dam has been clogged, and to obtain agreement with piezometer VWP10-04W-1 and VWP22-02W-3 readings of 859.5m and 900m it was necessary to assume the tailings beach is water saturated beneath its surface. For the East Dam, to obtain agreement with downstream piezometer VWP23-04E-2 and VWP19-01E-3 readings of 815.3m and 834m, it was necessary to assume 200m of the blanket/finger drain system downstream of the starter dam has been clogged, and to obtain agreement with piezometer VWP23-03E-2 and VWP23-01E-3 readings of 855m and 911.5m it was necessary to assume the tailings beach is water saturated beneath its surface. After this initial adjustment of drain permeability and seepage flow boundary conditions, material and drain permeabilities were calibrated to 2023 piezometer readings using FePEST. For both West/East Dam FePEST permeability calibrations, the effect on phreatic surface position was not substantial, but returned cycloned sand permeability  $5e^{-7}$ m/s was two orders of magnitude lower than reported in the 2021 DSR, and permeabilities ranging from  $3.3e^{-5}$ m/s to  $5.8e^{-3}$ m/s for sections of drain 0-100 and 100-200 meters downstream of the starter dams were returned. The low value of cycloned sand permeability is attributed to the presence of a structural zone intermediate between tailings and cycloned sand downstream slopes in which tailings and sand materials by 2 percent of waves are 1.7m and 1.3m. The setups for these waves, defined by the formula:

**Figure 5.** West/East Dam FEFLOW 2023 steady state seepage analysis with drain function, boundary conditions, and material permeabilities adjusted so the analysis hydraulic heads are in approximate agreement with 2023 piezometer readings.

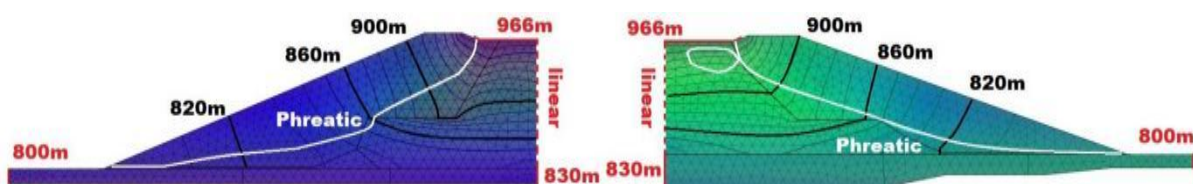
The design minimum freeboard of 2m assumes an initial freeboard of 5m is decreased by occurrence of a probable maximum flood. Because the 2023 ADSI reports a freeboard of 10m, transient seepage analysis has been performed assuming an increase in water level of 3m takes place with occurrence of a probable maximum flood of duration 72 hours, and that a month is required to pump the flood water out of the reservoir to return the pond height to its original level. **Figure 7** shows the West/East Dam transient seepage analysis in which phreatic surfaces are not significantly changed from steady state levels, but the hydraulic head of water saturated cycloned sand and tailings in vicinity the dam crests is increased by 10-20m in parts.

**Figure 7.** West/East Dam FEFLOW 2023 transient seepage analysis results for 3 day probable maximum flood decreasing dam freeboard by 3m.

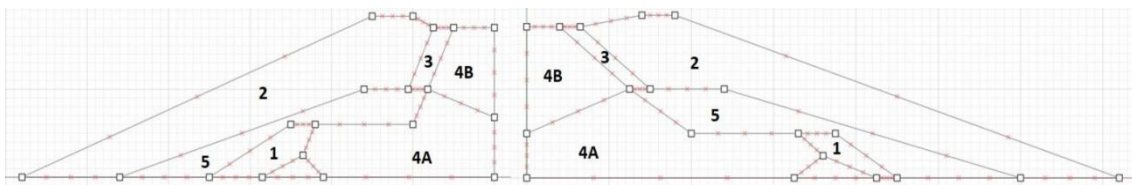
2019 CPT tests of the West Dam at 4 different locations at the crest and downstream slope indicate that for conservative assignment of the state parameter  $\psi$  to different parts of the dam, tailings/cycloned sand material above elevation 880m in the vicinity of the dam crest should be assigned a value of  $\psi$  between 0 and 0.1, while water saturated cycloned sand above and downstream of the West starter dam should be assigned a value of  $\psi$  between -0.05 and 0. Based on these 2019 CPT test results, the West Dam has been divided into 5 zones as shown in **Figure 8**, in which a liquefaction susceptible fifth zone consisting of water saturated cycloned sand has been added to the 1989 TSF Design Review zone division. In this figure, a similar zone division of the East Dam based on the 1989 TSF Design Review and 2019 CPT test results is also shown.

**Figure 8.** FLAC2D sketch of above foundation tailings/cycloned sand material in 2025 West/East Dam cross sections B2/A1 divided into zones 1:compacted cycloned sand, 2:uncompacted cycloned sand, 3:tailings sand+slimes, 4:tailings slimes, 5:water saturated cycloned sand based on the 1989 TSF Design Review, and the 2014 and 2023 ADSI reports. Zone 5 in each dam is distinguished from Zone 2 based on the results of 2019 CPT tests and 2023 piezometer data.

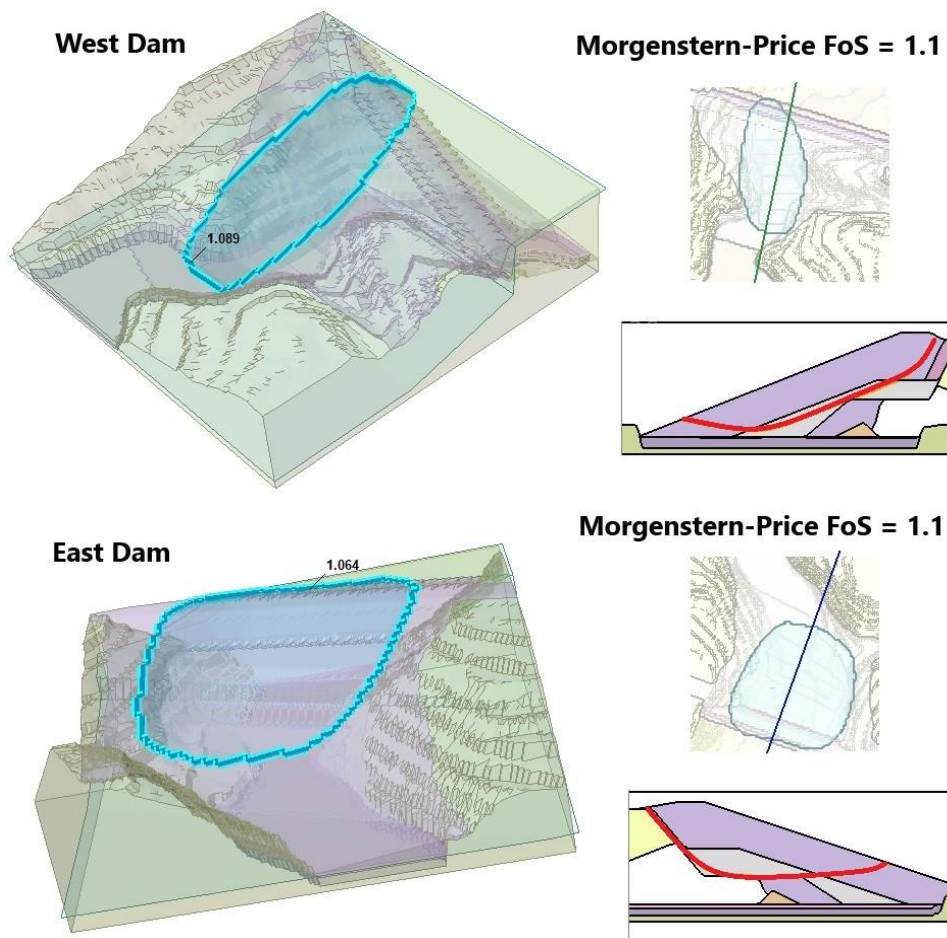
Post-liquefaction stability of the West and East Dams has been assessed by assigning residual undrained shear strength ratios of 0.22 and 0.07 to zones 4A and 4B, following the 2020 KCB stability analysis, and 0.055 to zones 3 and 5, assuming an SPT blow count value of 10 for water saturated cycloned sand based on the 1989 TSF Design Review and a residual undrained strength ratio multiplicative factor of 0.0055 [Klohn Leonoff, 1989, Stark, 1992]. **Figure 9** shows the resulting Slide3 Morgenstern-Price 3D limit equilibrium analysis FoS values of 1.1 and 1.1 for the West and East Dams, and the associated slip surfaces. **Table 7** shows FoS values similarly computed for different values of the unsaturated cycloned sand internal friction angle and water saturated sand SPT blow count. It is noted that while the assignment of residual undrained shear strength ratio of 0.055 to zone 5 is overly conservative based on 2019 CPT data, it is not known what post-2023 CPT data would show in regards to the current extent of water saturated cycloned sand and its liquefaction susceptibility [Robertson, 2010]. Moreover, it is not guaranteed Slide3 FoS computation is finding West/East Dam critical slip surfaces, although both intelligent search and addition of weak layers were attempted without lowering the returned Morgenstern-Price FoS. Slide3 allowance for tension cracking of the cycloned sand dam crests was not observed to have any effect on FoS or slip surface results.

**Figure 9.** Post-liquefaction FoS computation Slide3 results. Slip surfaces returned by classic ellipsoidal search with assignment of residual undrained shear strength ratios 0.22 to zone 4A, 0.07 to zone 4B, and 0.055 to zones 3 and 5.

- Chapter 8 - Conservative post-liquefaction analyses of West and East Dam 2025 FoS values indicate these values are less than 1.2 with liquefaction of water saturated cycloned sand. Although the 2021 DSR does not contain any recommendation to modify dam construction plans, based on the findings of this supplemental review, a professional engineering ITPR of
