Copper Mountain Mine Tailings Dam Safety Review Supplement

Daniel Brox

Abstract:—Copper Mountain Mine tailings dam slope stability research based on recommendations of the 2021 Tetra Tech Dam Safety Review, including computation of tailings dam factors of safety, satellite imagery, steady state and transient seepage analyses, and assessment of internal erosion risk. 3D dam factors of safety satisfy BC's normal operating legal requirement of 1.5 but are in possible violation of the post-seismic legal requirement of 1.2.

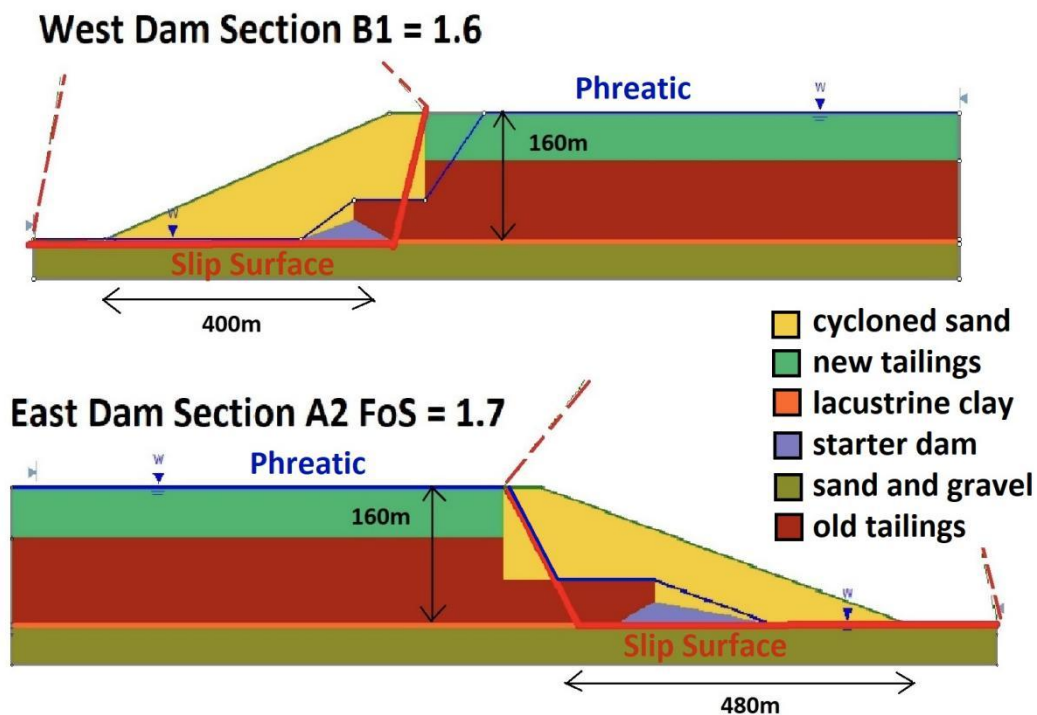
Figure 1-left shows the $FoS=1.6$ result of applying the 2D Morgenstern-Price limit equilibrium method in Rocscience Slide2 to compute the FoS of West Dam cross section B1 using an approximation of the 2020 KCB model, including the reported phreatic surface level, assignment of drained Mohr-Coulomb material shear strengths to dam construction and sand/gravel foundation materials, assignment of undrained SHANSEP material shear strength to lacustrine clay foundation material, and the reported critical slip surface. Material models/parameters used are listed in **Table 1**, in which the Mohr-Coulomb and SHANSEP models are abbreviated as MC and S. In this table, the densities of the sand and gravel foundation, lacustrine clay, starter dam, and old/new tailings are water saturated densities, while the density of cycloned sand is an unsaturated wet density.

Figure 1. Morgenstern-Price computed FoS for dam 2D cross sections based on 2020 KCB stability analyses [Tetra Tech, 2021].

Figure 1-right shows the $FoS=1.7$ result of applying the 2D Morgenstern-Price limit equilibrium method to compute the FoS of East Dam cross section A2 using a model approximating the 2020 KCB

model, including the reported phreatic surface level, assignment of drained Mohr-Coulomb material shear strengths to dam construction and sand/gravel foundation materials, assignment of undrained SHANSEP material shear strength to lacustrine clay foundation material, and the reported critical slip surface. It is important to note that neither the West nor East Dam 2D FoS computations reported here used a computer search algorithm to determine the dam critical slip surface, implying these 2D FoS values are overreported. It is also noted that in 2016, AMEC reported an end-of-construction FoS of 1.3 for a model of East Dam cross section A2 in which a continuous lacustrine clay layer was present in the foundation, while in 2020, KCB reported an FoS of 1.9 for the same cross section at time-of-construction.

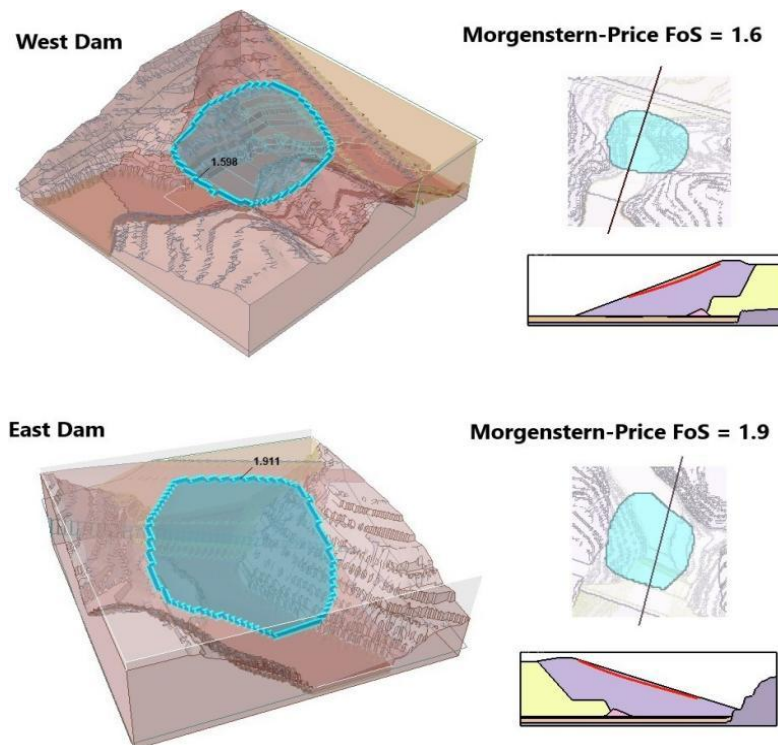
Figure 2 shows the result of computing 3D FoS values for the West Dam and East Dam in 2025 using Rocscience Slide3. The 3D models are based on valley topographic data provided by the foundation investigation documentation and 2016/2023 ADSI reports, and dam construction projections based on the 2023 ADSI report. Because the foundation investigation documentation showed boreholes in the vicinity of the West and East starter dams having average surface/bedrock elevations of 810.4m/795.4m and 811.8m/781.6m, while the 2023 ADSI specifies the West and East starter dam base elevations for sections B1 and A2 as being 800m, foundation topography was simplified by assuming uniform surface/bedrock elevations of 800m/780m, noting that the sand and gravel material in the foundation below the elevation of the surface lacustrine clay layers is not anticipated to affect failure dynamics. Model phreatic surfaces are based on calibration of FEFLOW 2D seepage analyses to 2023 piezometer data, and the assumption that water is ponded against the dam crests during a probable maximum flood event. For critical slip surfaces determined by the Slide3 classic ellipsoidal particle swarm search, the Morgenstern-Price FoS value is 1.6 for the West Dam, and 1.9 for the East Dam. The fact that neither 3D slip surface passes through the tailings and clay foundation demonstrates the importance of the narrowness of dam valley enhances stability of the dam slopes.

Figure 2. West Dam and East Dam 2025 3D Morgenstern-Price FoS values computed for critical slip surfaces determined by Rocscience Slide3 classic ellipsoidal particle swarm search. Phreatic surface levels are based on 2D FEFLOW seepage analysis of probable maximum flood conditions.

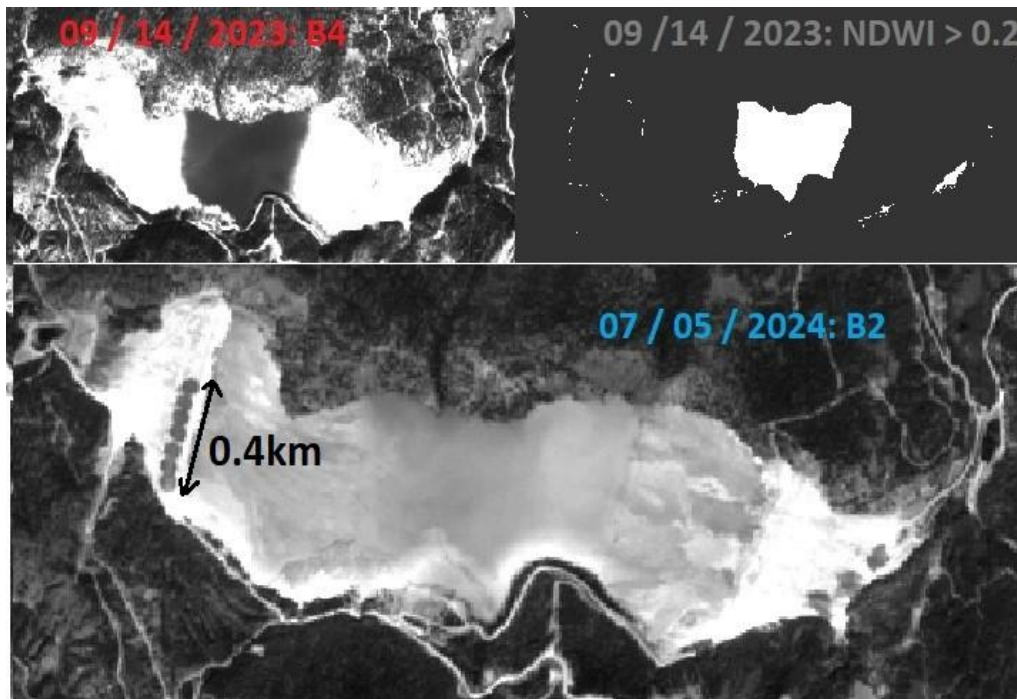
to detect presence of surface water, where B3 and B8 are the satellite measured reflectances in the green and near-infrared bands [Du, 2016, O'Donovan, 2022]. **Figure 3-top** shows images of the Copper Mountain Mine TSF on September 14, 2023, filtered in the red band B4 (left) and binary processed to display $NDWI > 0.2$ (right) to identify presence of surface water. **Figure 3-bottom** shows an image of the TSF on July 5, 2024, filtered through band B2 (blue-490nm), in which circular surface structures of approximate diameter 60 and 100km with optical reflectivity less than surrounding dam material are visible on the West and East dam downstream slopes. A hypothesis offered for presence of the structures in accordance with the 2021 DSR is that they were formed by sprinkler systems to limit dust generation.

Figure 3. Sentinel-2 images Copper Mountain Mine TSF, dated 09/14/2023 (top), and 07/05/2024 (bottom). Top images show the TSF in red band B4 (left), in which boundaries of the tailings pond are clear, and the same image binary processed for the condition $NDWI > 0.2$ (right) to identify presence of water at the surface of the TSF. The bottom image shows the TSF in blue band (B2) in which 7 circular structures on the West Dam crest/downstream slope of approximate diameter 60km and 3 circular structures on the East Dam downstream slope of approximate diameter 100m are

visible, and distinguishable from dam downstream slope, beach, and tailings pond materials by their reflectance in blue, red, and infrared bands.

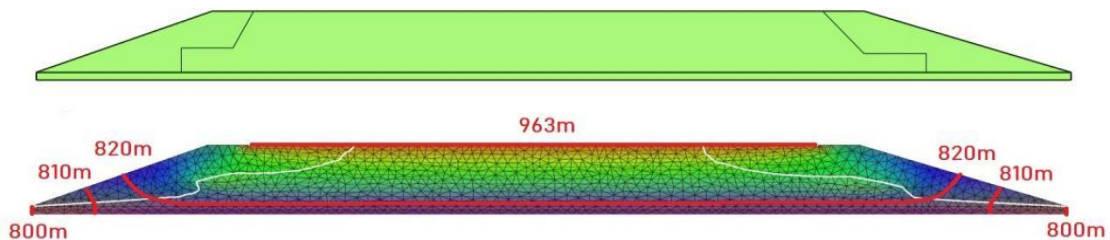
Figure 4 shows the FEFLOW computed 2023 phreatic surface level and hydraulic head isolines for the entire TSF and its foundation analyzed as a simplified 2 dam system in which constructed drains are omitted, beach lengths are 0m, and the material permeabilities listed in **Table 5** have been used. This analysis indicates the 2023 hydraulic head in TSF foundation upstream of West and East starter dams is approximately constant at 810m. The total seepage flows out of the West and East Dams are computed to be 1.4L/s/m and 1.2L/s/m, and in both cases more than 90 percent of this flow passes through the foundation. These seepage analysis results are in contrast to 2014 piezometer readings of VWP10-05W-3/VWP10-01E-3 in West/East Dam upstream foundations in excess of 835m/845m, pointing to the importance of considering the effect of 3D TSF geometry on

Figure 4. West/East Dam FEFLOW steady state analysis of 2023 2 dam system indicates hydraulic head in TSF foundation upstream of West and East starter dams is approximately constant at 810m.

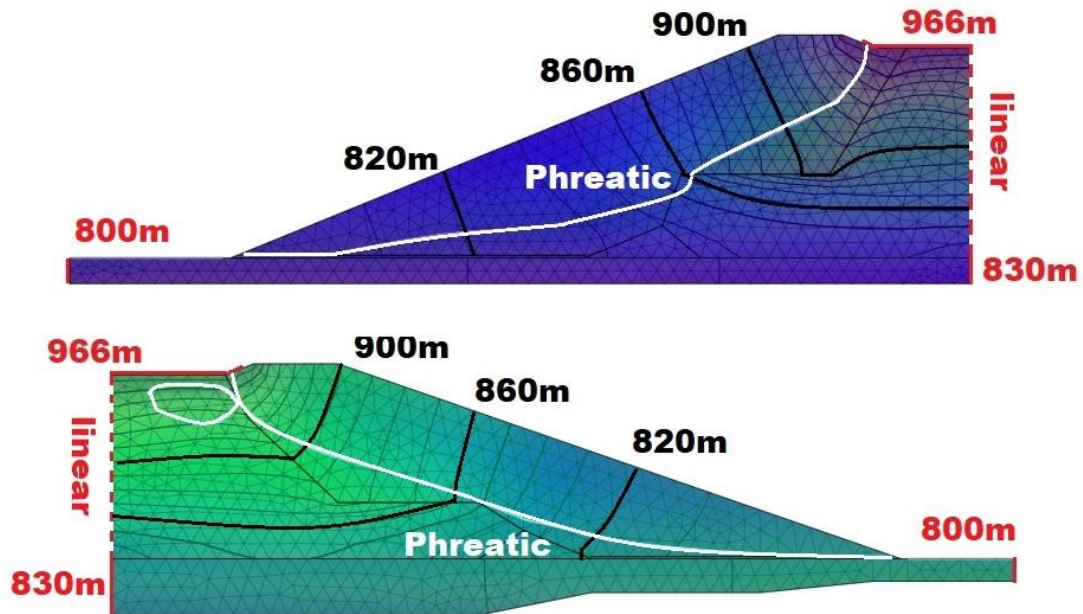
The design minimum freeboard of 2m assumes an initial freeboard of 5m is decreased by occurrence of a probable maximum flood. Because the 2023 ADSI reports a freeboard of 10m, transient seepage analysis has been performed assuming an increase in water level of 3m takes place with occurrence of a probable maximum flood of duration 72 hours, and that a month is required to pump the flood water out of the reservoir to return the pond height to its original level. **Figure 6** shows the West/East Dam transient seepage analysis in which phreatic surfaces are not significantly changed from steady state levels, but the hydraulic head of water saturated cycloned sand and tailings beneath the dam crests is increased by 10-20m.

Figure 6. West/East Dam FEFLOW 2023 transient seepage analysis results 30 days after 72 hour probable maximum flood decreases dam freeboard by 3m.

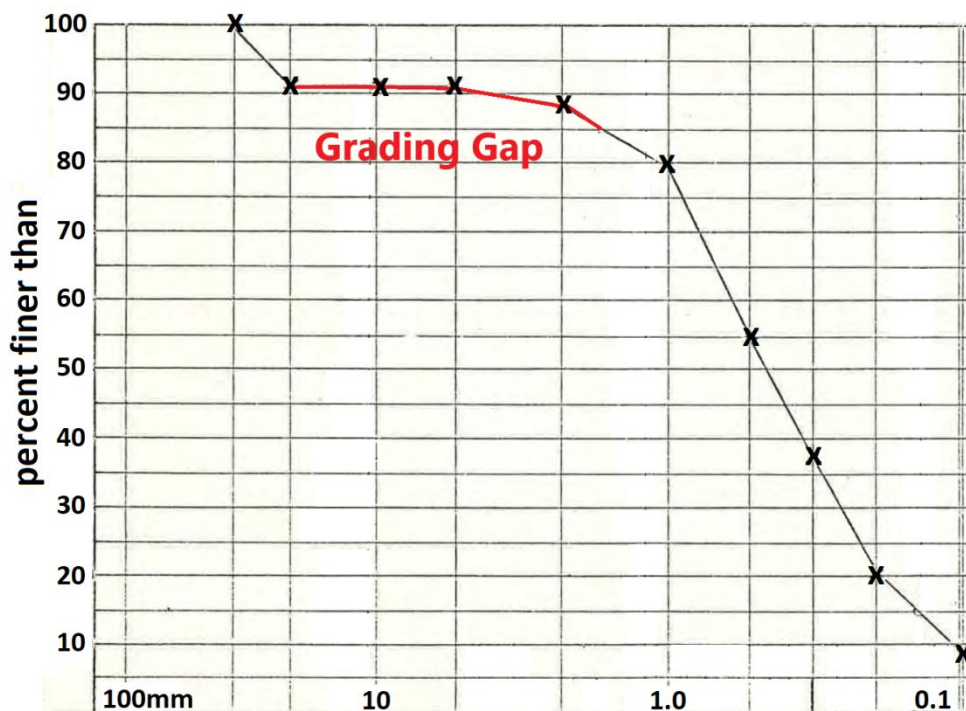
A condition on grain size distribution of a material indicating initiation of suffusion is the Kezdi criterion, which states suffusion may initiate if the difference in percent fines content between grain sizes D and $4D$ is less than 15 percent [Kezdi, 1979]. Based on the grain size distribution curve for silty gravelly sand recovered from borehole SL-9 in the East Dam foundation, shown in **Figure 7**, and the Kezdi criterion, the foundation material is susceptible to suffusion because of a gap in grading between 2 and 20mm grain sizes [Bechtel Ltd, 1971]. In principle, this suffusion could result in clogging of the gravel by transported fines that decreases its permeability over time [Fry, 2016].

Figure 7. Grain size distribution curve for silty gravelly sand 17.2 to 18.7 feet deep in borehole SL-9 in the East Dam foundation.

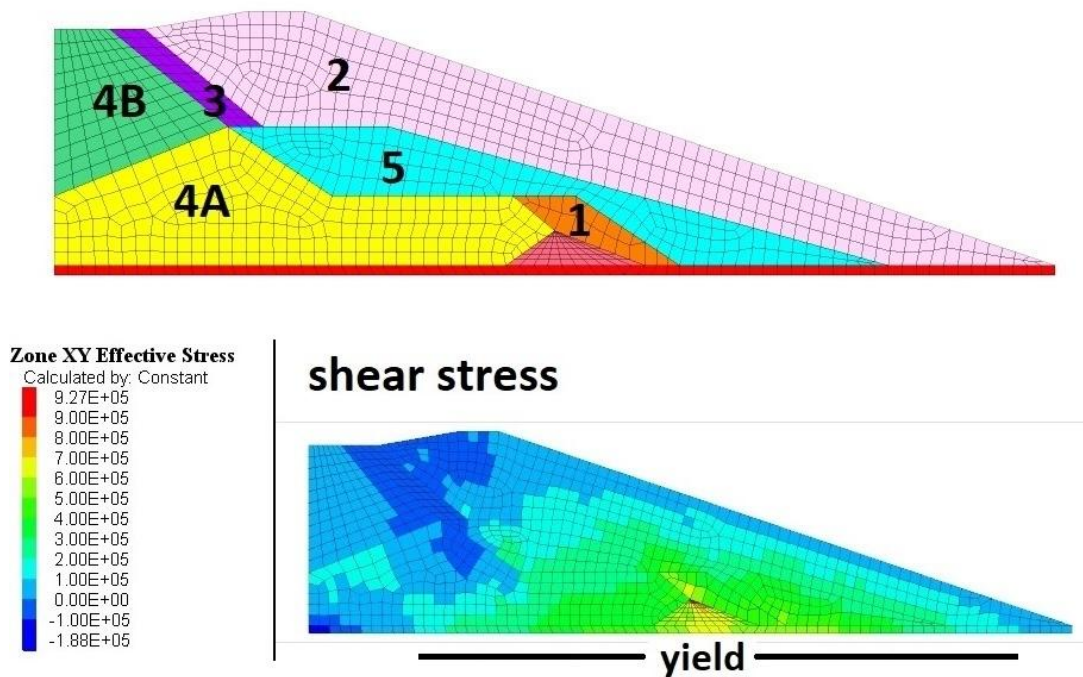
According to the 2021 DSR, inclinometer 12-02E has shown minimal displacement in the East Dam lower foundation, but in the upper foundation, tailings, and cycloned sand, material displacement rates have remained between 0.02 and 0.03mm/day from 2018 onward. In 2021, when Wolfe Creek was realigned with construction of an attenuation berm, inclinometer displacement rates temporarily decreased. A hypothesis offered for these observed displacements is that they are due secondary creep of lacustrine clay in the East Dam foundation stressed beyond its yield strength [Schneider, 2022]. If lacustrine clay preconsolidation stress of 200kPa is assumed based on literature, the clay is normally consolidated as reported by the 2021 DSR, and the effective overburden of the clay is conservatively equated to the preconsolidation stress, initial evidence for this hypothesis is provided by comparing the clay's SHANSEP undrained shear strength of $0.24(400)=96\text{kPa}$ with the FLAC2D computed shear stress in East Dam cross section A1, shown in **Figure 8**, in which the shear stress in the foundation exceeds the clay's undrained shear strength both immediately upstream and downstream of the starter dam [Dareeju, Zabolotnii, 2022]. InSAR and/or ground-based radar measurement of East Dam motion might verify this hypothesis. Staged construction analysis of the dam is necessary to more accurately approximate lacustrine clay pore water pressure and shear strength for identification of yield zones

Figure 8. FLAC2D computation of shear stress in 2025 East Dam cross section A1 shows the shear stress in the foundation exceeds the conservative 96kPa estimate of lacustrine clay yield strength both upstream and downstream of the starter dam. Dam zone labels 1:compacted cycloned sand, 2:uncompacted cycloned sand, 3:tailings sand + cyclone overflow, 4:tailings slimes, 5:water saturated cycloned sand.

- Chapter 7 - FLAC2D computation of shear stress in the East Dam suggests inclinometer displacements can be attributed to yield of lacustrine clay in the foundation. Staged construction analysis of the dam is necessary to more accurately approximate lacustrine clay pore water pressure and undrained shear strength for identification of yield zones

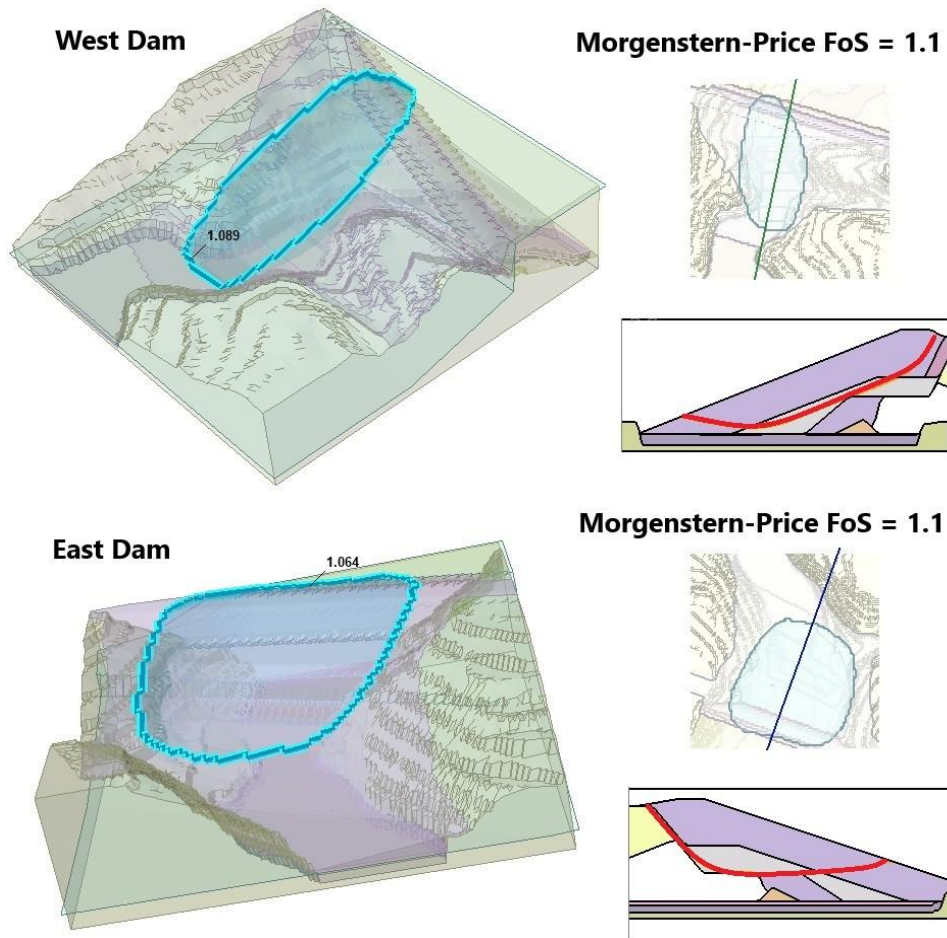
Post-seismic stability of the West and East Dams has been assessed by assigning residual undrained shear strength ratios of 0.22 and 0.07 to zones 4A and 4B, following the 2020 KCB stability analysis, and 0.055 to zones 3 and 5, assuming an SPT blow count value of 10 for water saturated cycloned sand based on the 1989 TSF Design Review and a residual undrained strength ratio multiplicative factor of 0.0055 [Klohn Leonoff, 1989, Stark, 1992]. **Figure 9** shows the resulting Morgenstern-Price 3D FoS values of 1.1 and 1.1 computed in Slide3 for the West and East Dams, and the associated critical slip surfaces. **Table 7** shows FoS values similarly computed for different values of the unsaturated cycloned sand internal friction angle and water saturated sand SPT blow count. It is noted that while the assignment of residual undrained shear strength ratio 0.055 to zone 5 is overly conservative based on 2019 CPT data, it is not known what current CPTu data shows in regards to the extent of water saturated cycloned sand and its liquefaction susceptibility [Robertson, 2010]. It is also not guaranteed that Slide3 FoS computation is finding West/East Dam critical slip surfaces, although both intelligent search and addition of weak layers were attempted without lowering the returned Morgenstern-Price FoS. Slide3 allowance for tension cracking of the cycloned sand dam crests was not observed to have any effect on FoS or slip surface results.

Figure 9. Post-seismic Morgenstern-Price FoS computation results in Slide3.

- Chapter 8 - Conservative post-seismic stability analyses of 2025 West and East Dam FoS values indicate these values are less than 1.2 with liquefaction of water saturated cycloned sand. Based on the findings of this supplemental review, a professional engineering ITPR of West/East Dam internal erosion and liquefaction hazard is warranted, and required for initiation of any necessary dam rehabilitation operations. Therefore, at this point in time it is important for the Engineer of Record, with full knowledge of the TSF design and construction history, to publicly state their current appraisal of TSF dam structural stability so there can be public and private engineering consensus regarding what if any additional structural testing and rehabilitation operations are required.

If liquefaction triggered slope instability is identified by direct measurement as an ongoing threat to dam stability, drainage of excess pore water pressure in the tailings beaches and/or relief wells drilled down into the foundation may be necessary. To avoid the complication of correctly

predicting liquefaction triggers, it should be noted that current best practice is to assume liquefaction could be triggered and design/construct dams to a post-seismic stability standard $FoS > 1.1$ [International Commission on Large Dams, 2019, O'Brien, 2020].
