Copper Mountain Mine Tailings Dam Safety Review Supplement

Daniel Brox, PhD (Electrical and Computer Engineering, UBC, 2014)

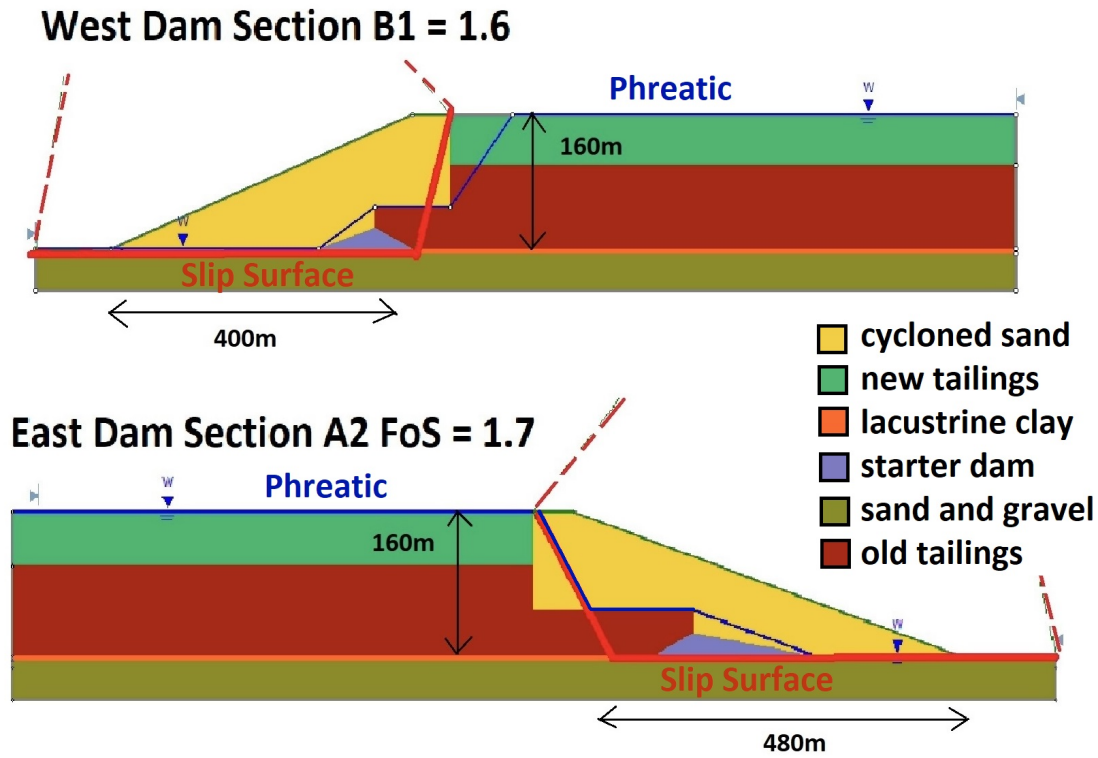
Fig. 1. Morgenstern-Price computed FoS for dam 2D cross sections based on 2020 KCB stability analyses [39].

Figure 1-left shows the FoS=1.6 result of applying the 2D Morgenstern-Price limit equilibrium method in Rocscience Slide2 to compute the FoS of West Dam cross section B1 using an approximation of the 2020 KCB model, including the reported phreatic surface level, assignment of drained Mohr-Coulomb material shear strengths to dam construction and sand/gravel foundation materials, assignment of undrained SHANSEP material shear strength to lacustrine clay foundation material, and the reported critical slip surface. Material models/parameters used are listed in **Table 1**, in which the Mohr-Coulomb and SHANSEP models are abbreviated as MC and S. In this table, the densities of the sand and gravel foundation, lacustrine clay, starter dam, and old/new tailings are water saturated densities, while the density of cycloned sand is an unsaturated wet density.

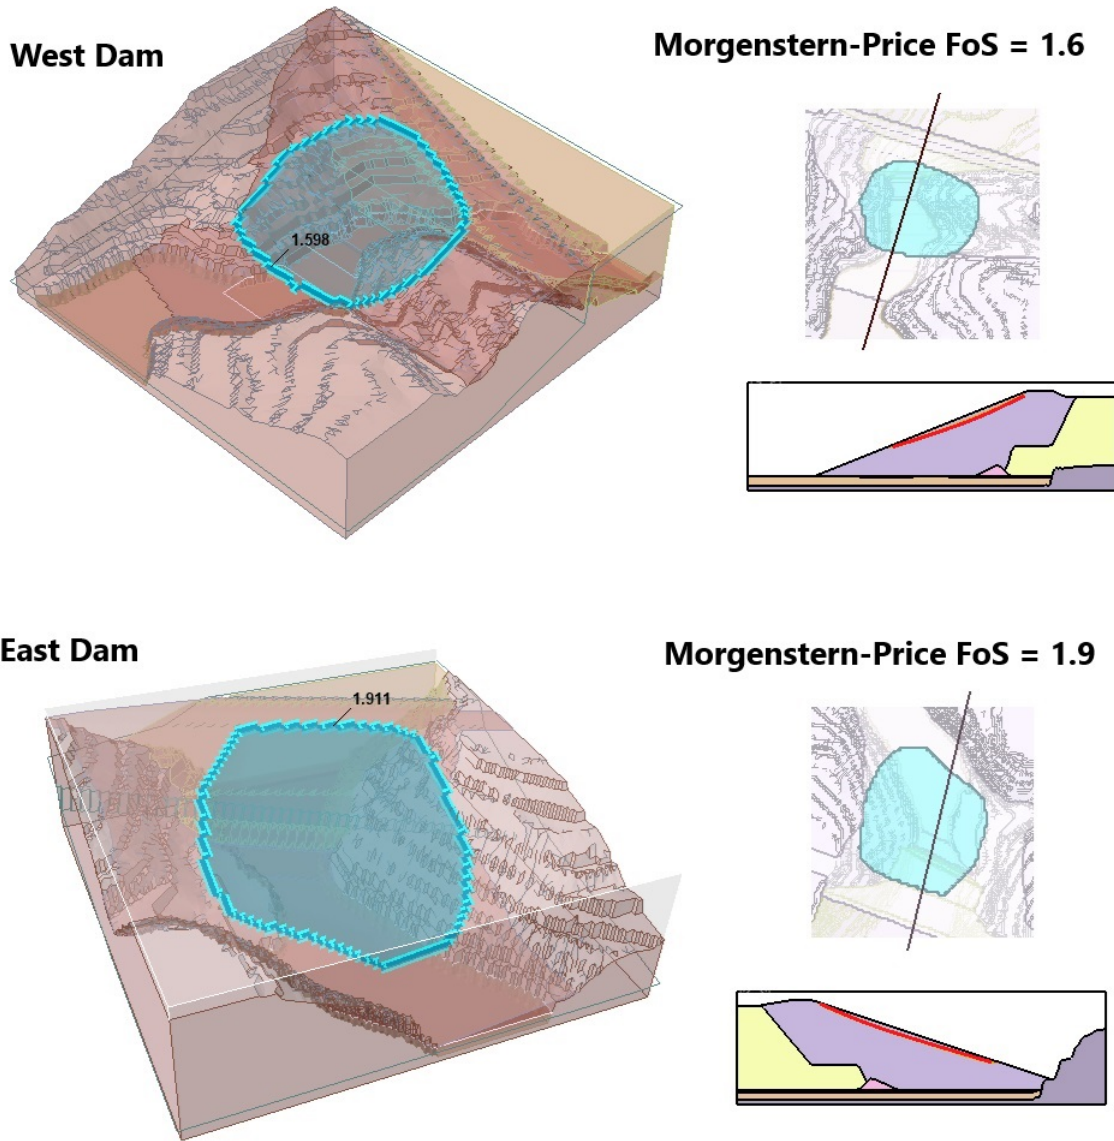
Fig. 2. West Dam and East Dam 2025 3D Morgenstern-Price FoS values computed for critical slip surfaces determined by Rocscience Slide3 classic ellipsoidal particle swarm search. Phreatic surface levels are based on 2D FEFLOW seepage analysis of probable maximum flood conditions.

maximum flood event. For critical slip surfaces determined by the Slide3 classic ellipsoidal particle swarm search, the Morgenstern-Price FoS value is 1.6 for the West Dam, and 1.9 for the East Dam. The fact that neither 3D slip surface passes through the tailings and clay foundation suggests the the narrowness of the dam valley enhances stability of the dam slopes.

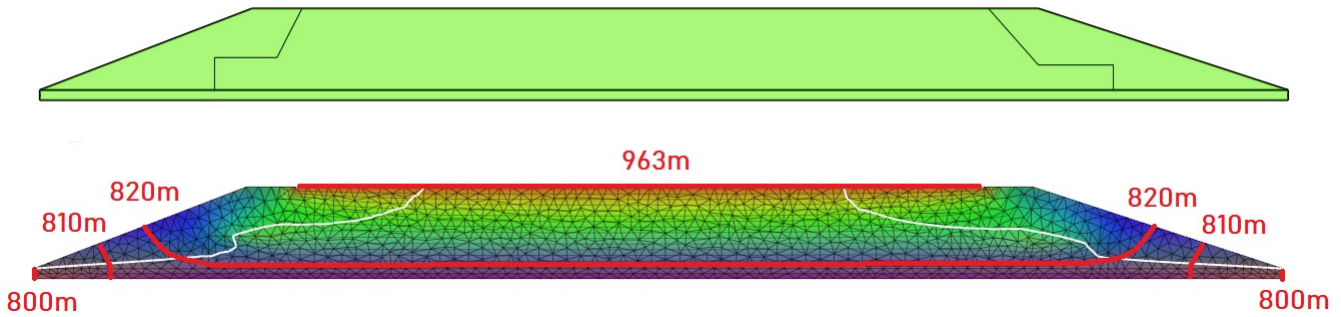
Fig. 4. West/East Dam FEFLOW steady state analysis of 2023 2 dam system indicates hydraulic head in TSF foundation upstream of West and East starter dams is approximately constant at 810m.

of the West and East Dams are computed to be 1.4L/s/m and 1.2L/s/m, and in both cases more than 90 percent of this flow passes through the foundation. These seepage analysis results are in contrast to 2014 piezometer readings of VWP10-05W-3/VWP10-01E-3 in West/East Dam upstream foundations in excess of 835m/845m, pointing to the importance of considering the effect of 3D TSF geometry on seepage flow and accounting for any low permeability path from the TSF pond through the TSF abutments into the foundation [24].

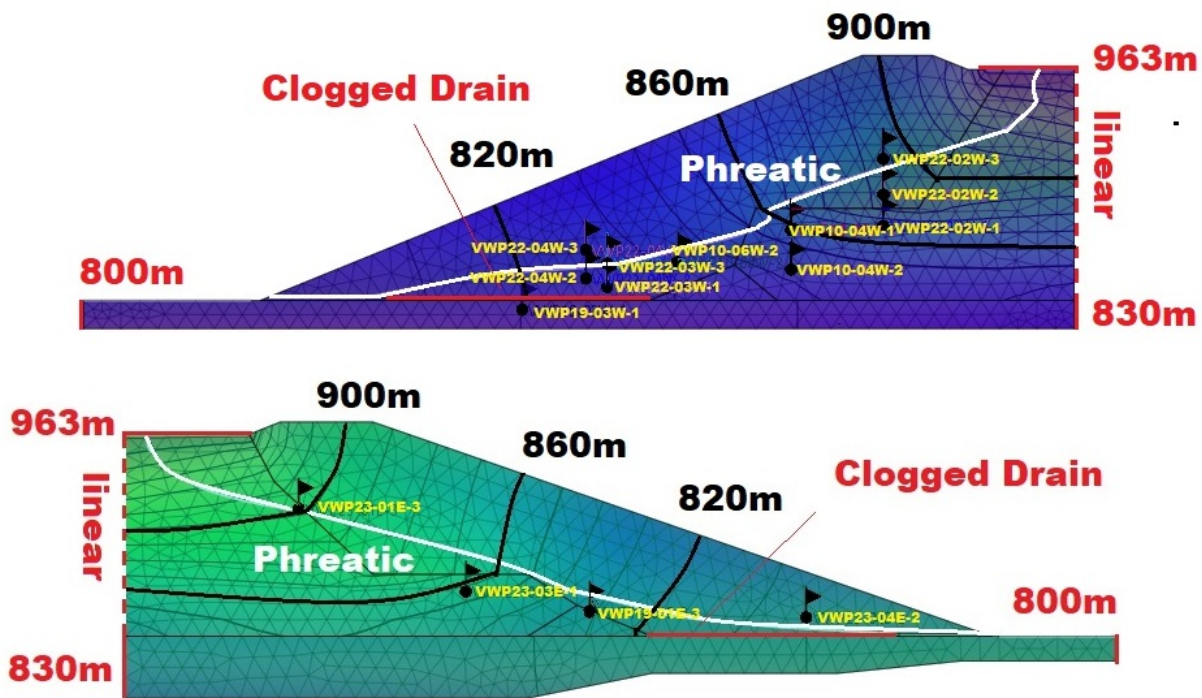
Fig. 5. West/East Dam FEFLOW 2023 steady state seepage analysis with drain function, boundary conditions, and material permeabilities calibrated to 2023 piezometer readings.

Figure 5 shows West/East Dam FEFLOW steady state seepage analyses with drain function and boundary conditions adjusted to obtain approximate agreement of hydraulic heads with 2023 readings of West/East Dam piezometer readings. For both dams, an upstream foundation total head of 830m

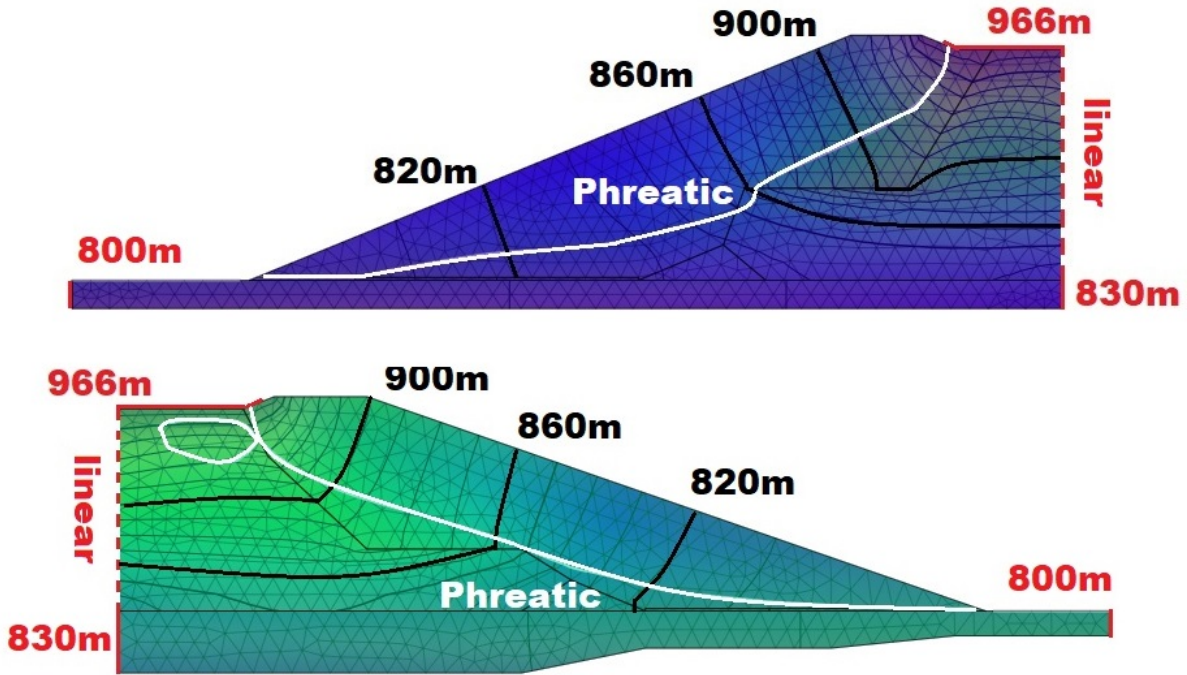
Fig. 6. West/East Dam FEFLOW 2023 transient seepage analysis results 30 days after 72 hour probable maximum flood decreases dam freeboard by 3m.

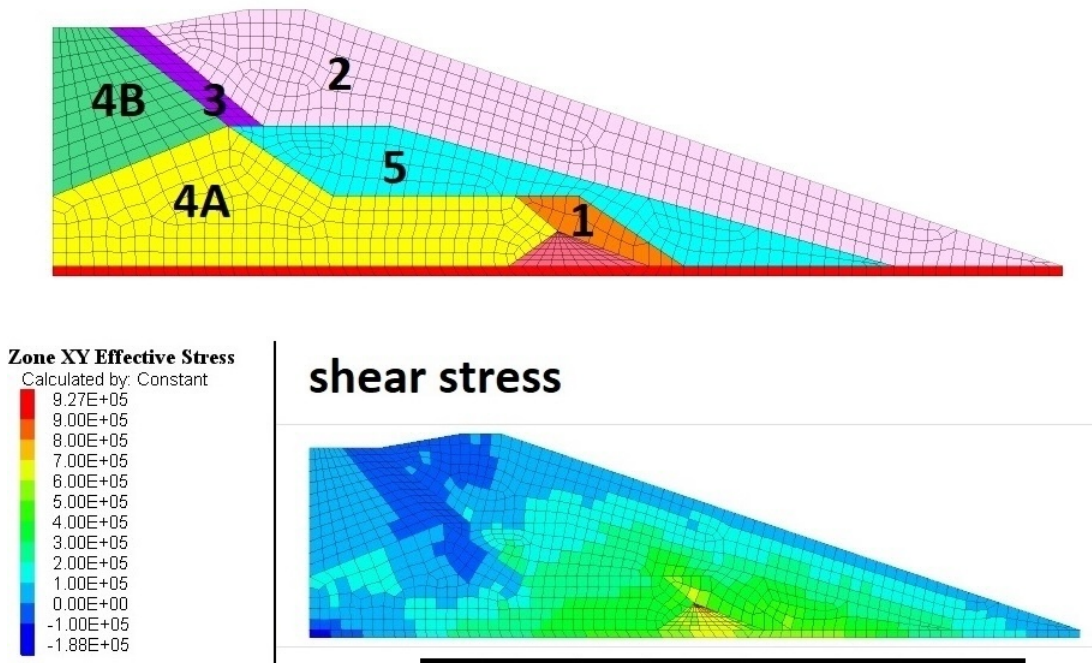
Fig. 8. FLAC2D computation of shear stress in 2025 East Dam cross section A1 shows the shear stress in the vicinity of the starter dam and its foundation exceeds 100kPa. Dam zone labels 1:compacted cycloned sand, 2:uncompacted cycloned sand, 3:tailings sand+cyclone overflow, 4:tailings slimes, 5:water saturated cycloned.

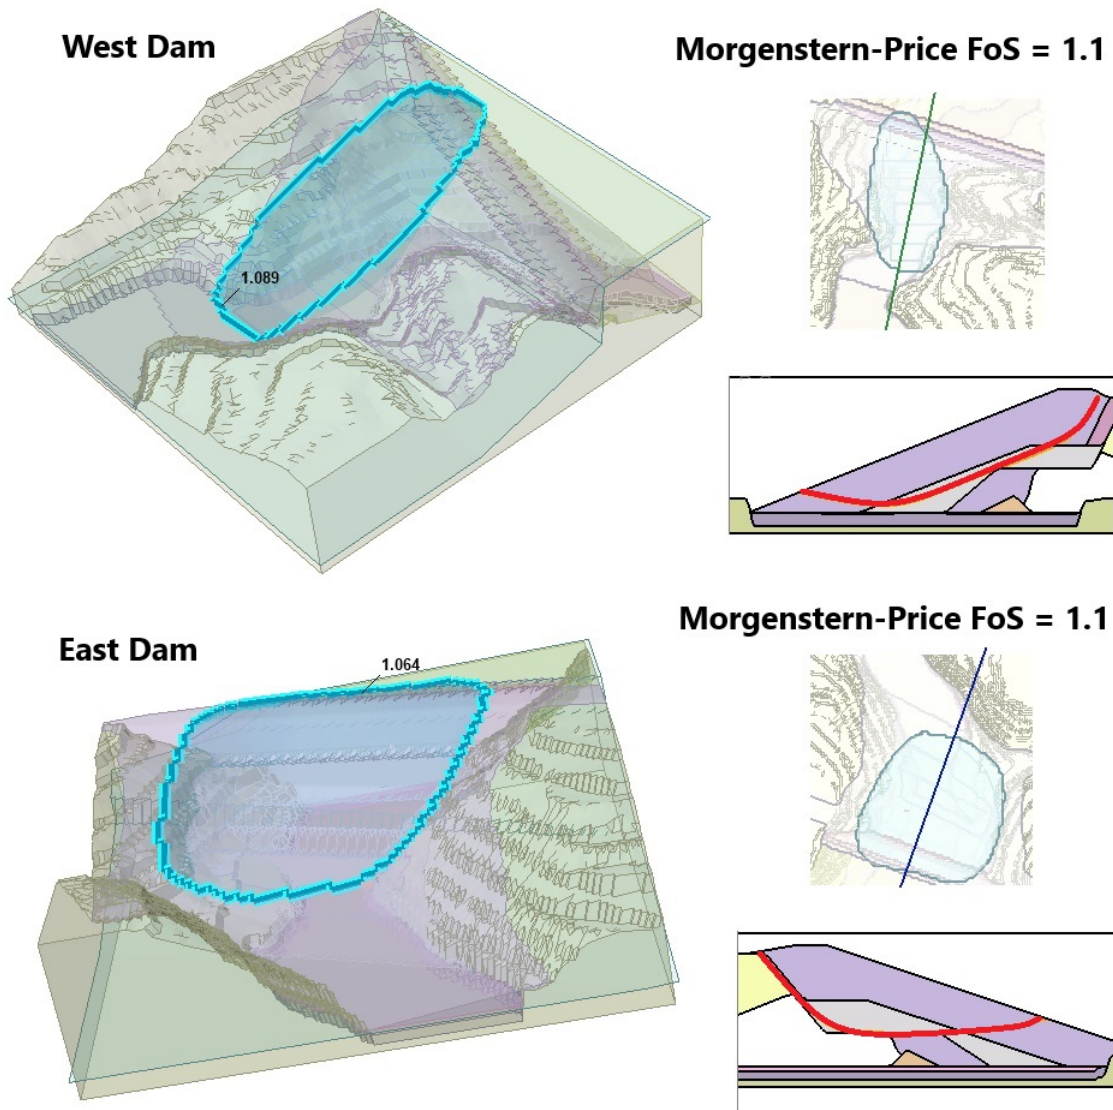
Fig. 9. Post-liquefaction Morgenstern-Price FoS computation results in Slide3.

- Chapter 6 - Marked increases in West Dam recycle sump outflow before 2020 and East Dam toe drain outlet seepage flow before 2023, preceding decrease in seepage flows and marked increase in piezometer PZ10-02W and PZ15-02E total head readings, are possible evidence of internal erosion pipe formation and collapse.
- Chapter 7 - FLAC2D computation of shear stress in the East Dam suggests inclinometer displacements can be attributed to secondary creep of water saturated material in the vicinity of the starter dam and its foundation.
- Chapter 8 - Conservative post-liquefaction stability analyses of 2025 West and East Dam FoS values indicate these values are less than 1.2 with liquefaction of water

If liquefaction triggered slope instability is identified by direct measurement as an ongoing threat to dam stability, drainage of excess pore water pressure in the tailings beaches and/or water saturated cycloned sand regions by wick drains and/or relief wells drilled down into the foundation may be necessary. To avoid the complication of correctly predicting liquefaction triggers, it should be noted that current best practice is to assume liquefaction could be triggered and design/construct dams to a post-seismic stability standard $FoS > 1.1$ [21], [31].
