Copper Mountain Mine Tailings Dam Safety Review Supplement

Daniel Brox, PhD (Electrical and Computer Engineering, UBC, 2014)

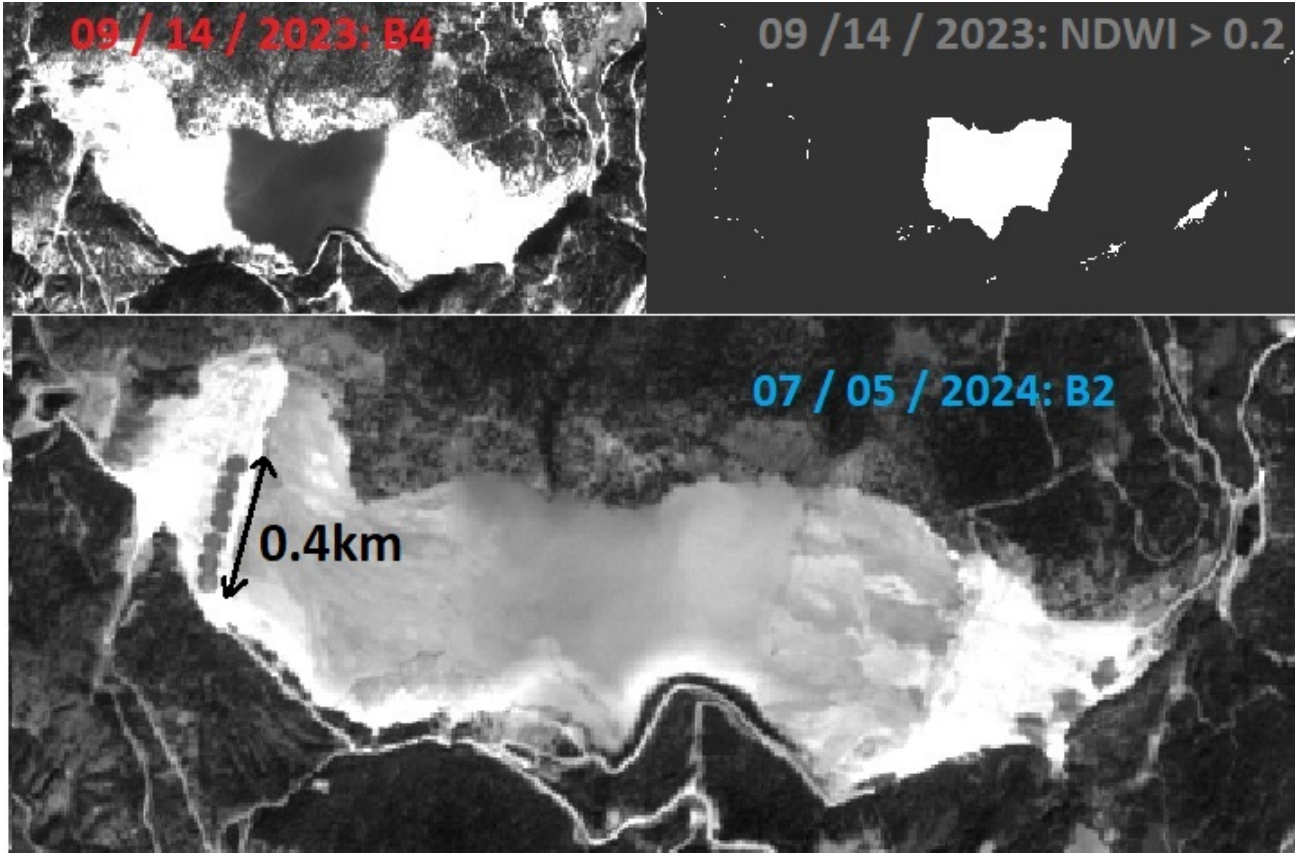
Fig. 3. Sentinel-2 images Copper Mountain Mine TSF, dated 09/14/2023 (top), and 07/05/2024 (bottom). Top images show the TSF in red band B4 (left), in which boundaries of the tailings pond are clear, and the same image binary processed for the condition $NDWI > 0.2$ (right) to identify presence of water at the surface of the TSF. The bottom image shows the TSF in the blue band (B2) in which 7 circular structures on the West Dam crest/downstream slope of approximate diameter 60km and 3 circular structures on the East Dam downstream slope of approximate diameter 100m are visible, and distinguishable from dam downstream slope, beach, and tailings pond materials by their reflectance in blue, red, and infrared bands.

satellite measured reflectances in the green and near-infrared bands [32], [11]. **Figure 3-top** shows images of the Copper Mountain Mine TSF on September 14, 2023, filtered in the red band B4 (left) and binary processed to display $NDWI > 0.2$ (right) to identify presence of surface water. **Figure 3-bottom** shows an image of the TSF on July 5, 2024, filtered through band B2 (blue-490nm), in which circular surface structures of approximate diameter 60 and 100km with optical reflectivity less than surrounding dam material are visible on the West and East dam downstream slopes. A hypothesis offered for presence of the structures in accordance with the 2021 DSR is that they were formed by sprinkler systems to limit dust generation.

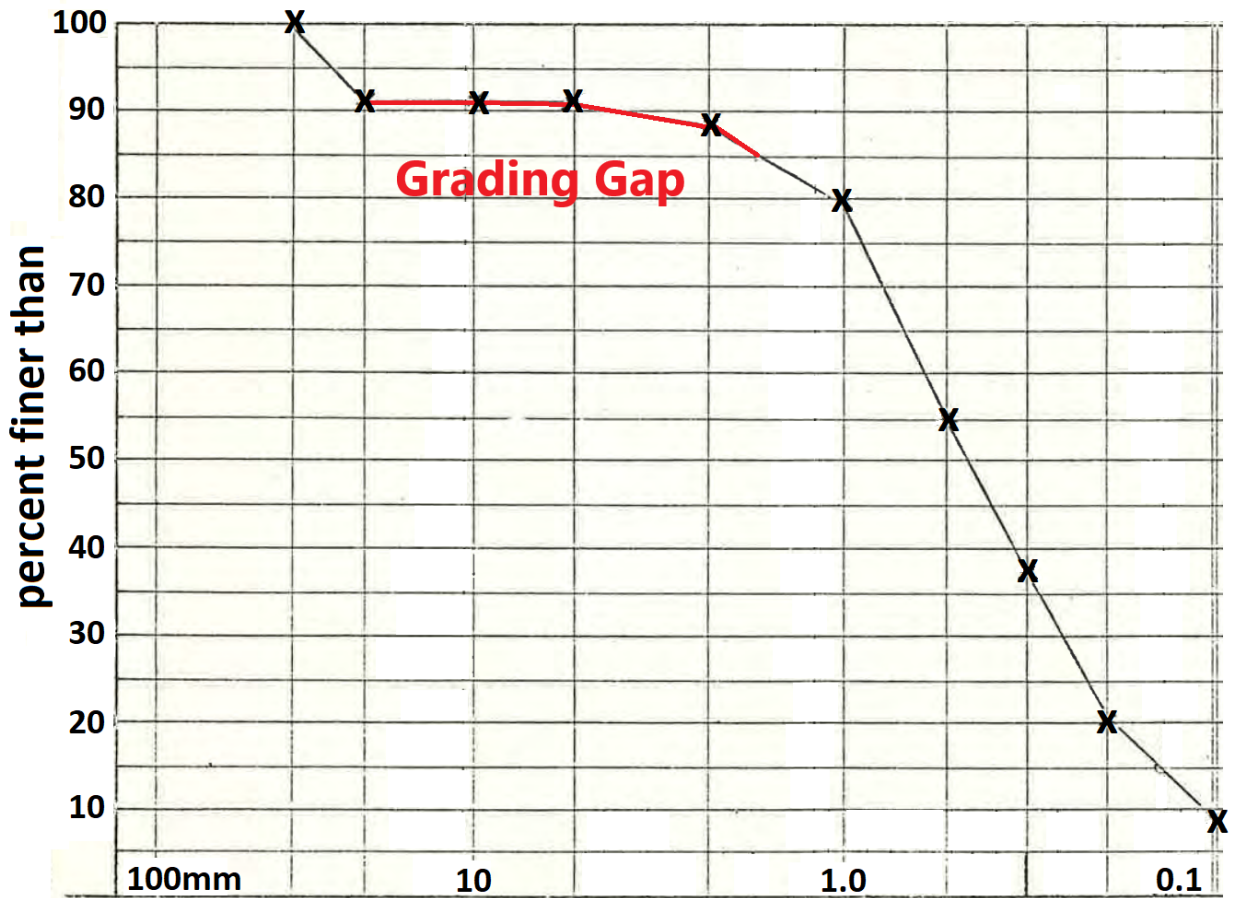
A condition on grain size distribution of a material indicating initiation of suffusion is the Kezdi criterion, which states suffusion may initiate if the difference in percent fines content between grain sizes D and $4D$ is less than 15 percent [26]. Based on the grain size distribution curve for silty gravelly sand recovered from borehole SL-9 in the East Dam foundation, shown in **Figure 7** and the Kezdi criterion, the foundation material is susceptible to suffusion because of a gap in grading between 2 and 20mm grain sizes [5]. In principle, this suffusion could result in clogging of the gravel by transported fines that decreases its permeability over time [17].

Fig. 7. Grain size distribution curve for silty gravelly sand 17.2 to 18.7 feet deep in borehole SL-9 in the East Dam foundation.
